Inspection Report

**7788 Ships Point Road
Fanny Bay BC**

Clarity Home Inspections Ltd.

Date: 2021-11-17	Time: 09:00 AM	Report ID: 21-7506
Property: 7788 Ships Point Road Fanny Bay BC	Customer: Kathy Schmidt Rick Jamison	Real Estate Professional: PRE-LISTING INSPECTION BY OWNER

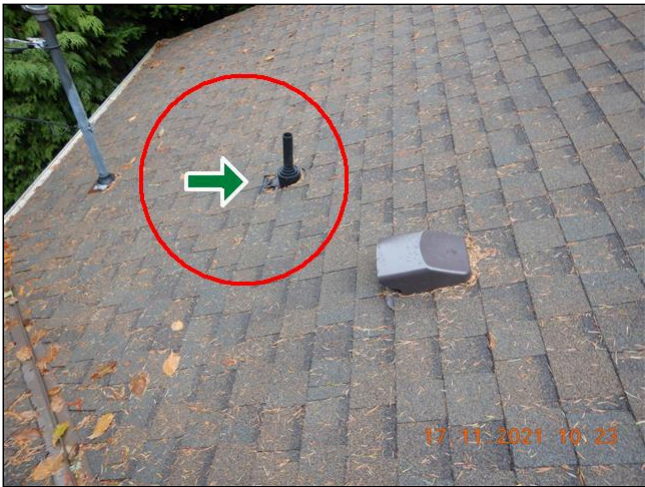
1.2 Item 1(Picture) Front elevation

1.2 (1) The plumbing vent flashing above the bathroom has significant deterioration and is vulnerable to moisture penetration. Replacement by a qualified roofing contractor is advised to prevent water ingress and damage to the interior of the home.

Time to complete - ASAP

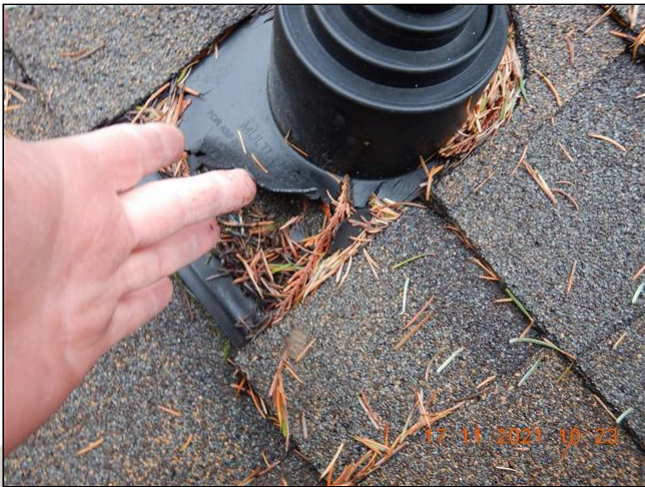
1.2 Item 2(Picture) Flashing damage

(1) The plumbing vent flashing above the bathroom has significant deterioration and is vulnerable to moisture penetration. Replacement by a qualified roofing contractor is advised to prevent water ingress and damage to the interior of the home.

Time to complete - ASAP

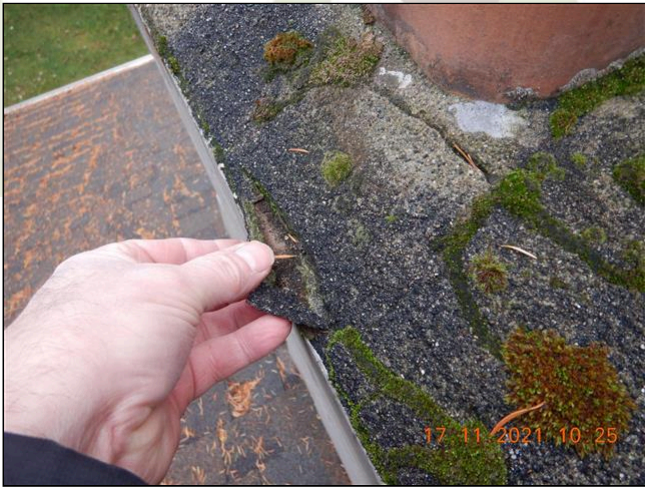
1.2 Item 3(Picture) Chimney crown

1.2 (2) Minor cracking and mortar displacement was noted in the chimney crown. To prevent moisture ingress and further deterioration of the chimney structure it is advised that the cracks be sealed or at best replacing the crown. It would be prudent to cap the redundant clay flue to prevent moisture ingress and extend the serviceable life of the chimney structure. This is not a priority repair.

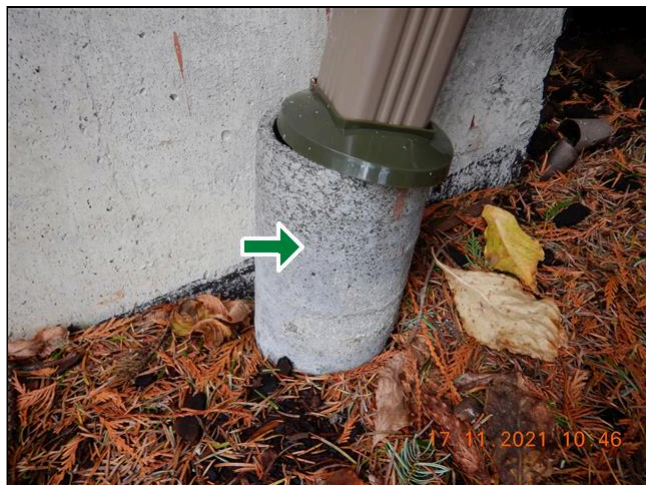
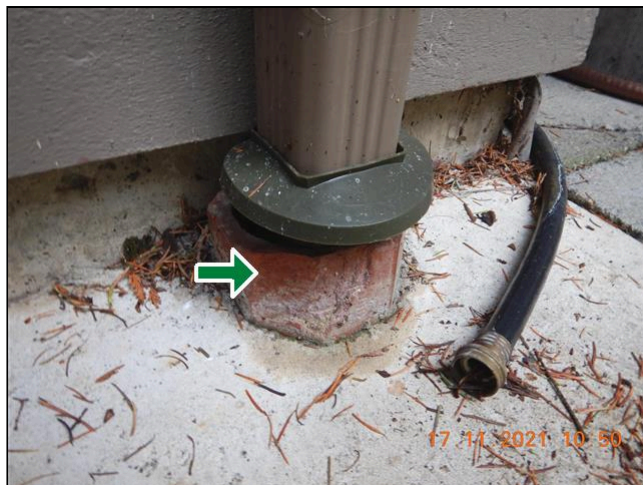
1.3 Item 1(Picture) Old drainage system

🔍 **1.3 FYI** - The downspouts discharge into a below ground drainage system, inspection of which is beyond the scope of this inspection. Due to the age of this home it is recommended that the drains be inspected/scoped by drainage specialists to determine functionality. No defects with respect to drainage issues in and around the foundations and basement were noted.

FYI - The downspouts discharge into a below ground drainage system, inspection of which is beyond the scope of this inspection. Due to the age of this home it is recommended that the drains be inspected/scoped by drainage specialists to determine functionality. No defects with respect to drainage issues in and around the foundations and basement were noted.

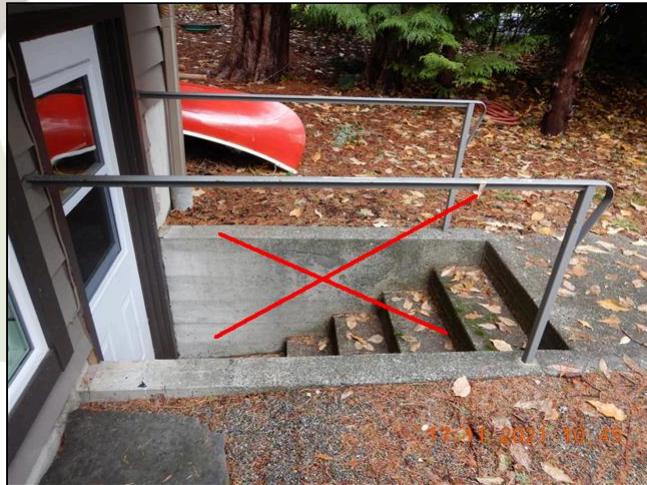
2.7 Item 1(Picture) Fall hazard

🔍 **2.7** The basement staircase guardrail is a fall hazard, especially for small children. Assess any perceived risks for your family and guests and install spindles, spaced appropriately for safety reasons.

The basement staircase guardrail is a fall hazard, especially for small children. Assess any perceived risks for your family and guests and install spindles, spaced appropriately for safety reasons.

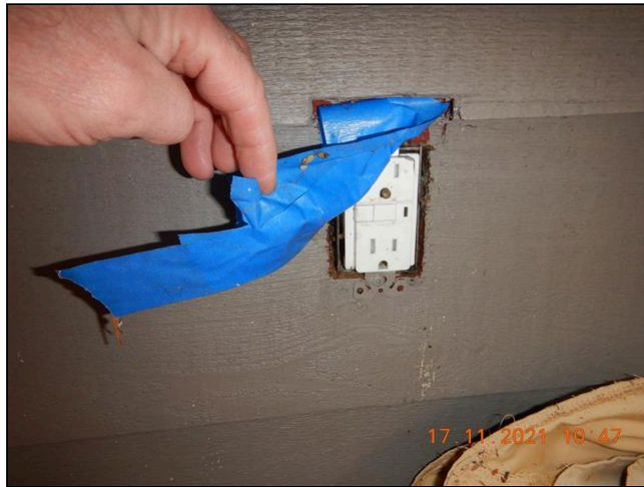
2.9 Item 1(Picture) NW elevation

2.9 The exterior receptacle at the NW side of the home requires a cover plate for safety reasons.

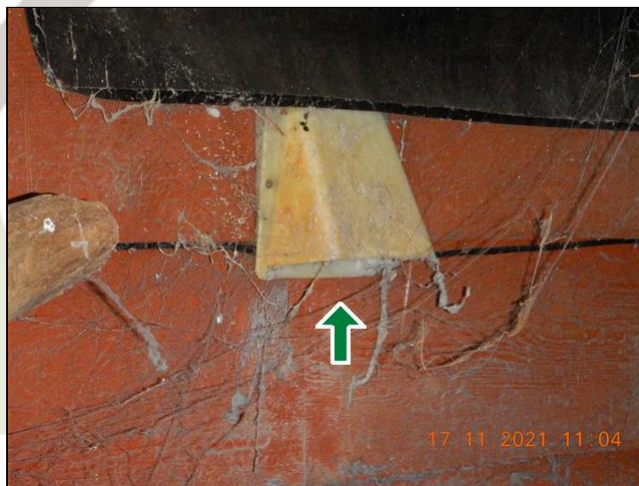
4.6 Item 1(Picture) Dryer vent

4.6 (1) FYI - The dryer vent is located below the front deck. Access is challenging for regular maintenance and repair.

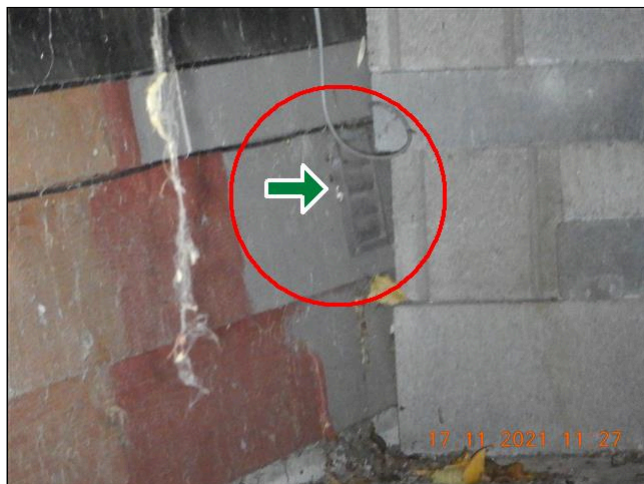
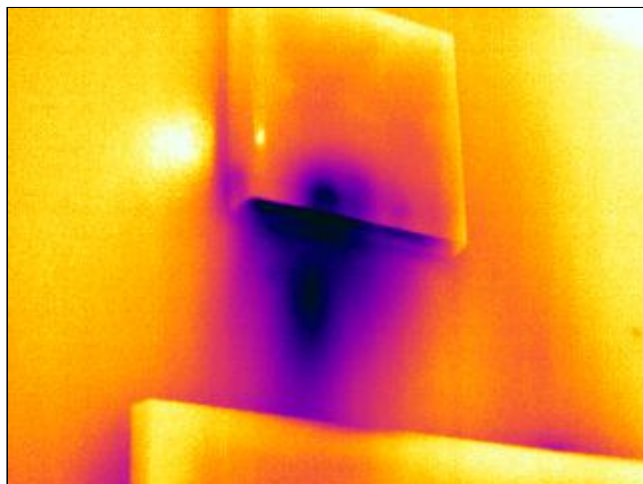
4.6 Item 2(Picture) Under front deck

4.6 (2) The exterior vent for the basement bathroom exhaust fan appears to be the wrong type for this application. Updating is recommended to prevent cold air entering the home when the fan is not in use.

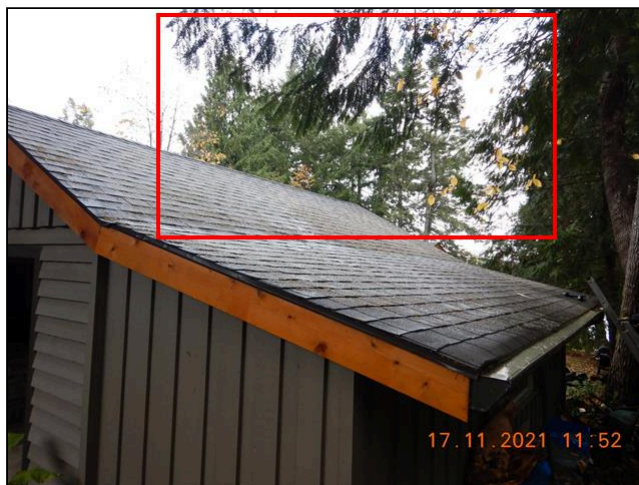
5.0 Item 1(Picture) Tree limbs

5.0 FYI - Tree limbs that are in contact with or hanging near the garage/workshop roof should be trimmed. Failure to correct will result in premature wear of the roof surface and gutter blockage.

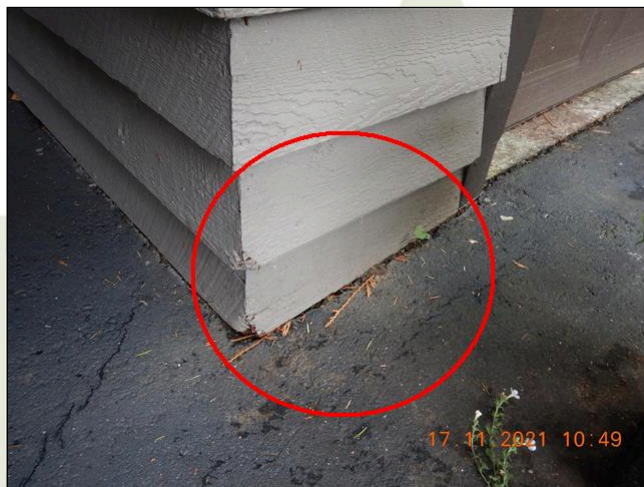
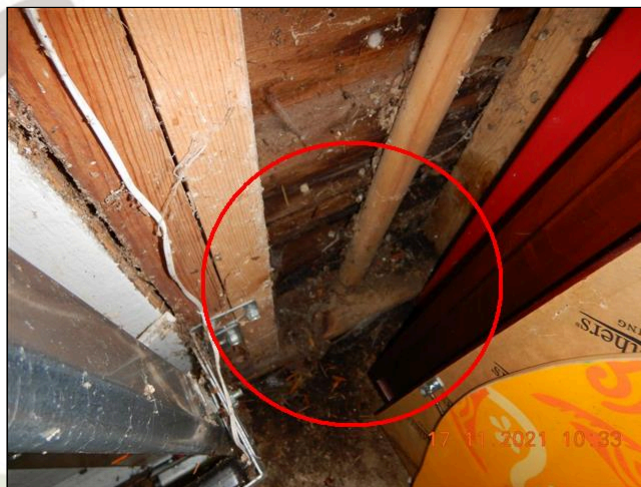
5.1 Item 1(Picture) Garage-front corner

5.1 The wall structure at the front of the garage is close to grade level and vulnerable to moisture wicking. Keep areas free of debris to prevent excess moisture in this location.

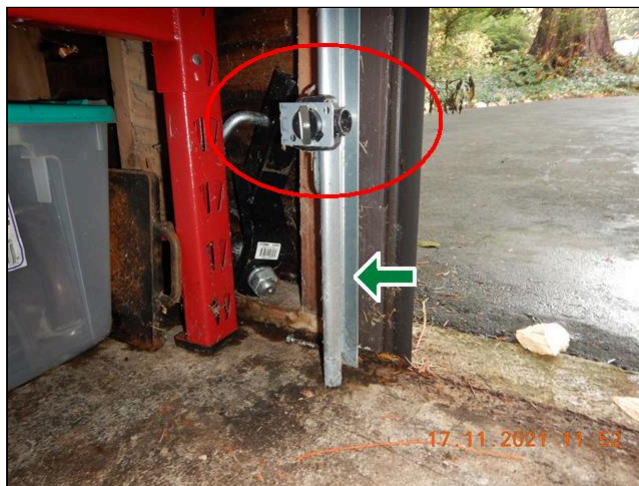
5.6 Item 1(Picture) Garage door sensors

5.6 The garage door will reverse when met with resistance.

The sensors are in place for garage door(s) and will reverse the door.

FYI - The garage door sensors are installed too high. Adjusting to 6-8" from floor level is recommended.

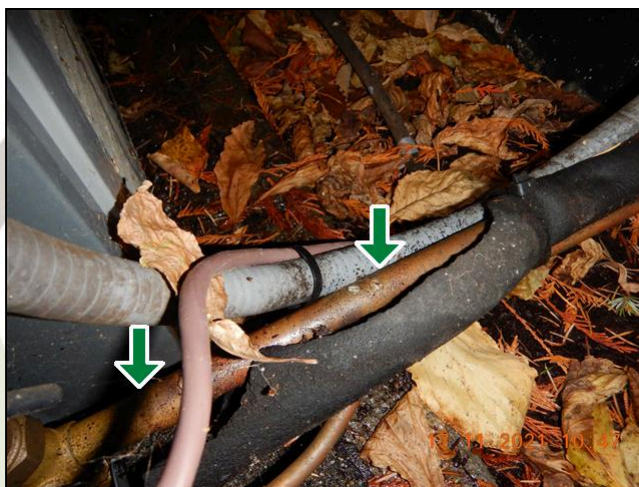
6.3 Item 1(Picture) Heat pump

🔍 **6.3 (1)** The large copper refrigerant line (suction line) at the heat pump should be fully insulated along its entire length. Repair is advised to maintain system performance.

(1) The large copper refrigerant line (suction line) at the heat pump should be fully insulated along its entire length. Repair is advised to maintain system performance.

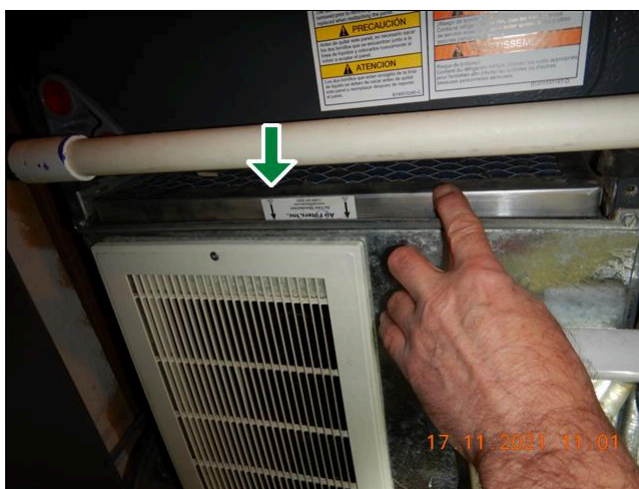
6.3 Item 2(Picture) Furnace filter

6.3 (2) The washable furnace filter is dirty and needs cleaning or replacement. To maintain maximum system performance clean or replace the filter on a regular basis. The cabinet beside the furnace makes it challenging to replace or clean the filter.

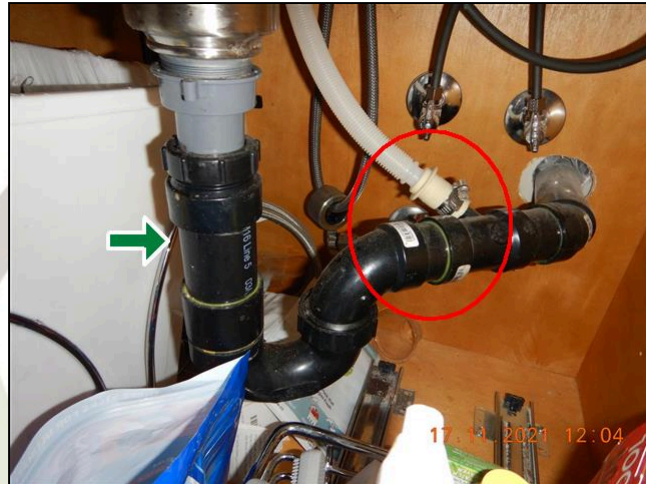
8.0 Item 1(Picture) Dishwasher drain

🔍 **8.0** Dishwasher drain hoses cannot be directly connected to the waste plumbing system unless it's connected upstream (before) a trap. The implication of connecting downstream (after) the trap is a cross connection at the dishwasher (cross connection means possible contamination of the potable water supply). Repair by a licensed plumber is recommended.

Dishwasher drain hoses cannot be directly connected to the waste plumbing system unless it's connected upstream (before) a trap. The implication of connecting downstream (after) the trap is a cross connection at the dishwasher (cross connection means possible contamination of the potable water supply). Repair by a licensed plumber is recommended.

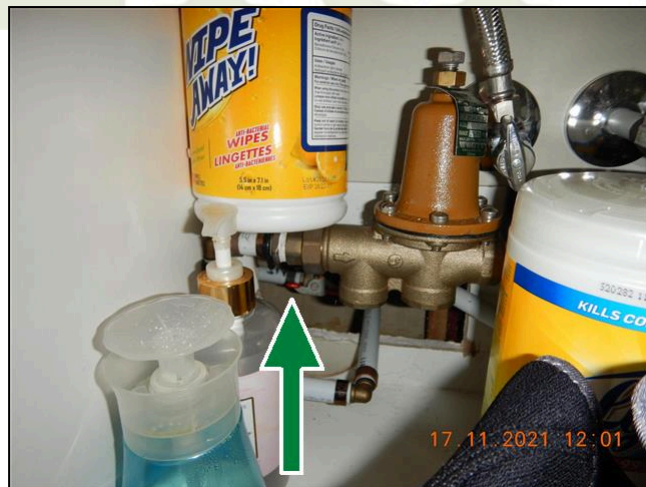
8.3 Item 1(Picture) Basement

8.3 FYI - The main water shut off is located in the basement bathroom.

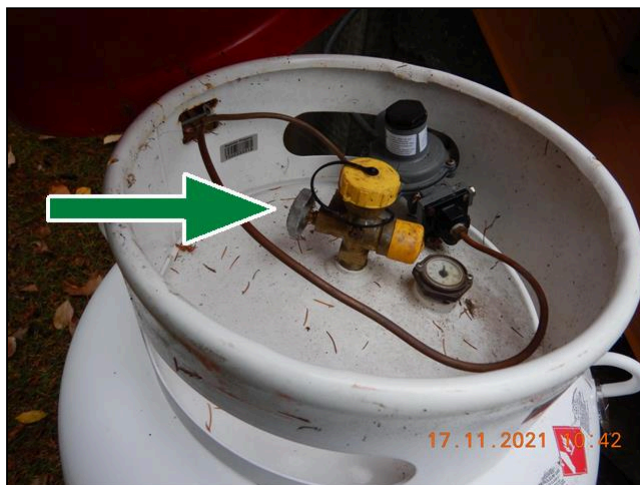
8.5 Item 1(Picture) East corner

8.5 FYI - The main fuel shut off is at the propane tank on the East corner of the home.

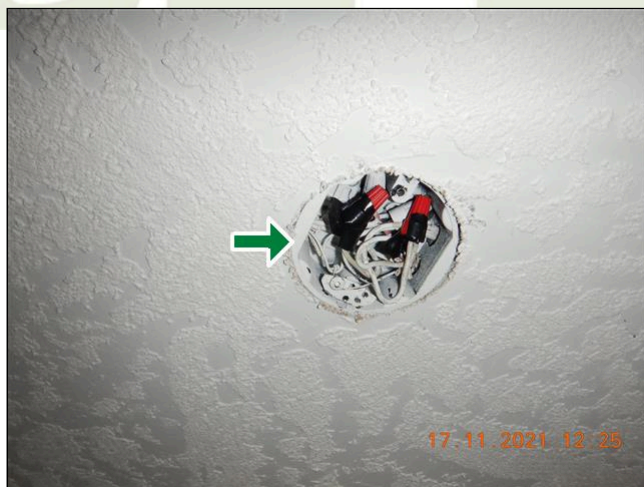
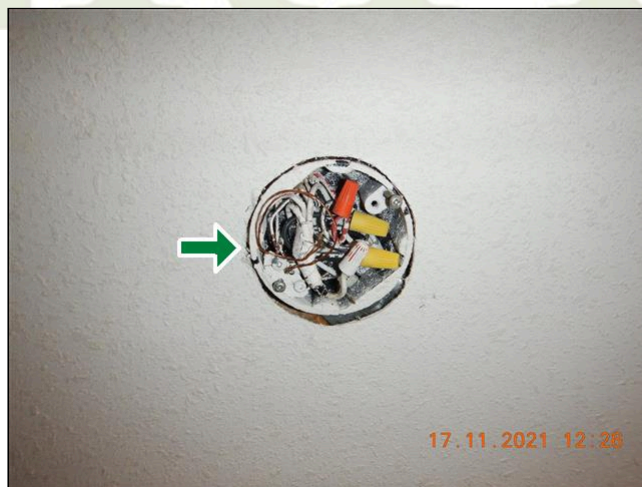
9.5 Item 1(Picture) Basement bedroom

**9.5** All receptacles, junction boxes and light switches should be fitted with cover plates for safety reasons. This is not a priority repair but correction is advised.

All receptacles, junction boxes and light switches should be fitted with cover plates for safety reasons. This is not a priority repair but correction is advised.

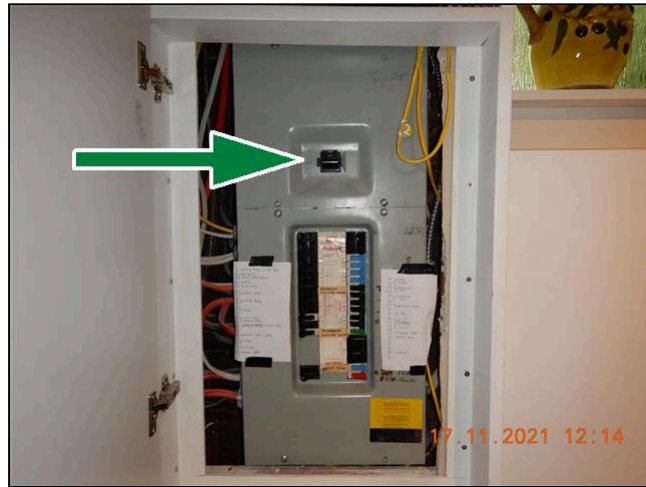
9.8 Item 1(Picture) Basement

9.8 FYI - The main electrical disconnect is located in the basement den.

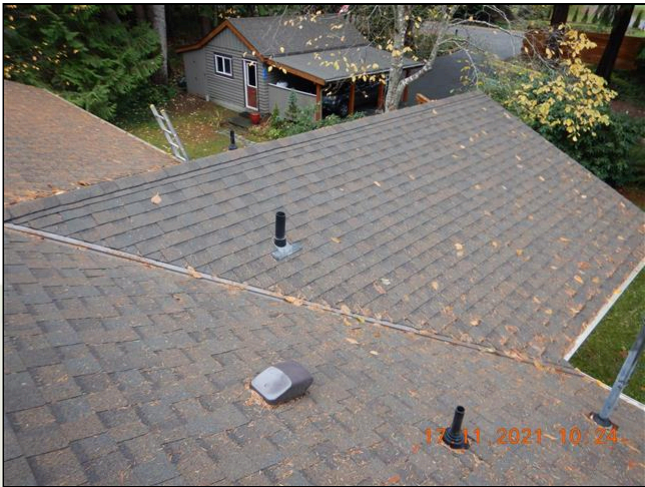
11.0 Item 3(Picture) Roof condition

11.0 FYI - Exterior views and informational images for home insurance provider.
